**IN THE UNITED STATES DISTRICT COURT
FOR THE DISTRICT OF MINNESOTA**

**COMPLAINT AND DEMAND FOR JURY
TRIAL**

Swagelok Company, a foreign corporation,

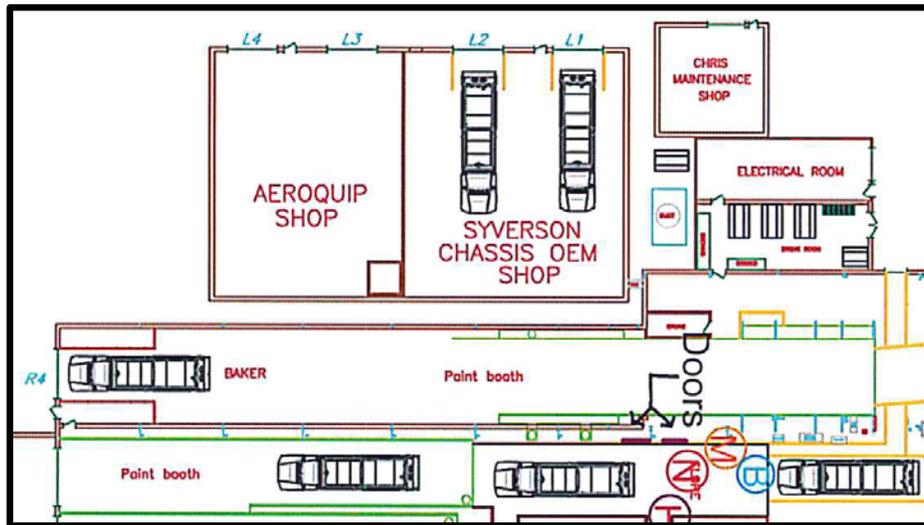
13. The location within the McNeilus facility where the January 11, 2017, explosion occurred - identified as line 6 - included three separate areas where CNG-powered refuse trucks being assembled progress from east to west. As shown in the diagram below, trucks under assembly move from a paint and touch-up booth to a heated baking room and then to a showroom. The explosion on January 11, 2017, occurred in paint booth 6 (marked as R4 below).

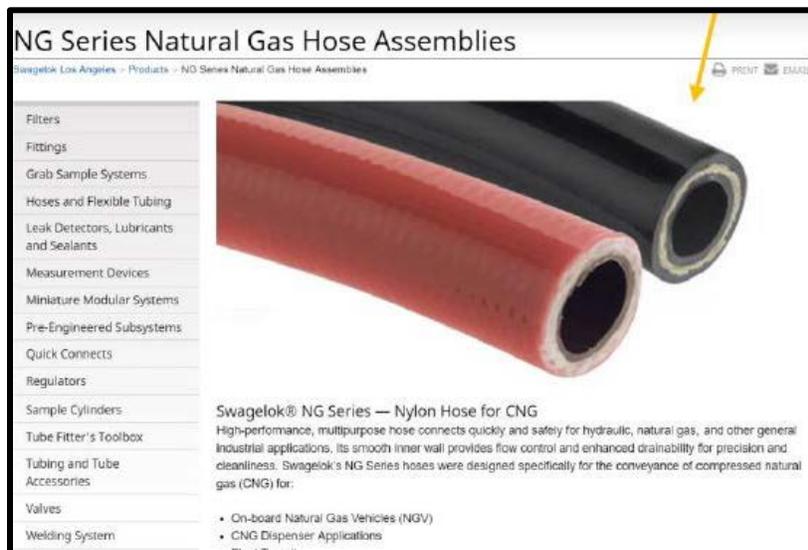
25. Defendant Swagelok designed and manufactured the CNG hoses and fittings on the subject truck. Swagelok produces and sells a variety of application-specific hose assemblies, including those shown below used in CNG systems.

26. Upon information and belief, the black Swagelok hose depicted above is the same type of hose that was involved in the January 11, 2017, explosion. Defendant Swagelok also manufactures and sells the fittings that are attached to the hoses by Swagelok personnel and which are sold as integrated hose assemblies to be connected to other components in the truck's CNG system.

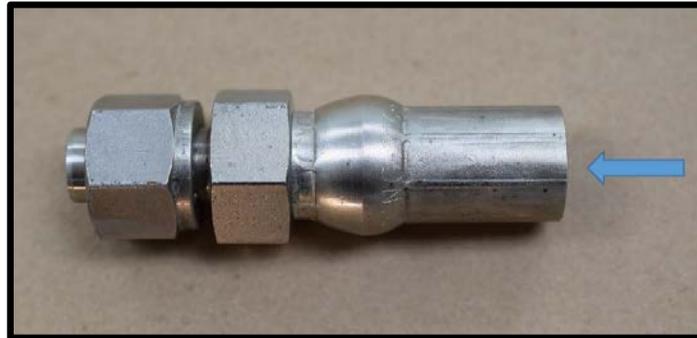
28. The image below depicts the fitting manufactured by Swagelok which attached to the hose that separated from the subject truck's CNG module on January 11, 2017, resulting in the release of pressurized natural gas that caused the explosion.

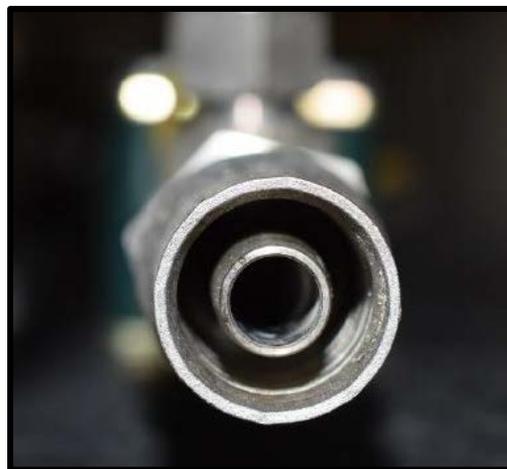
29. The image below shows the interior of the Swagelok fitting (viewed from the vantage point of the right side of the above-pictured fitting) involved in the explosion.

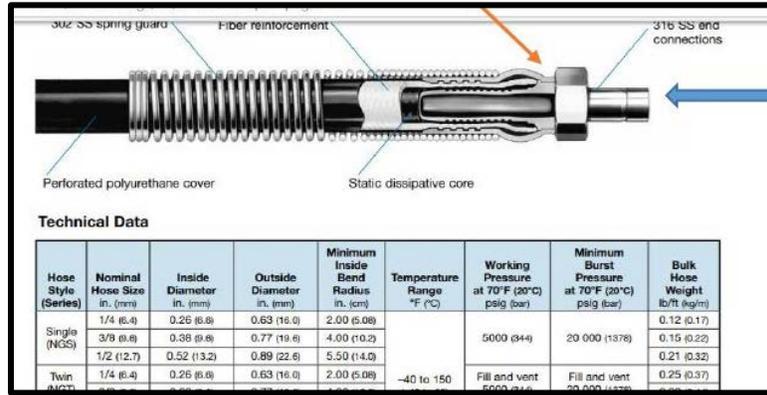
31. The image below, from Swagelok marketing materials, shows a cross section of a properly seated hose-fitting connection (note that the hose is flush with the end connection of the fitting, as shown by the orange arrow):

30. The process by which the Swagelok hose is designed to be mated to the fitting involves fully inserting the hose into the space between the inner (smaller diameter) barb and the outer (larger diameter) collar and then compressing the outer metal collar against it. Circumferential rings on the inner barbs within the fitting engage with the hose after compression of the outer collar in order to create a leak-proof fitting able to withstand the pressure rating for the hose. A more technical definition of this process is as follows:

A fitting attachment method utilizing a number of fingers or dies mounted in a radial configuration. The dies close perpendicular to the hose and fitting axis, compressing the collar, ferrule, or sleeve around the hose.

32. The failure mode leading to the January 11, 2017, explosion can be summarized as follows: for the joining process to work (i.e., to create a leak-proof seal able to withstand the pressure for which the hose is rated and which the CNG system demands), the Swagelok hose must be inserted all the way into the fitting before the mechanical pressure of the compression process is applied. If the hose is not fully inserted, circumferential rings distal to the hose insertion depth are unable to engage with the hose, resulting in a partial connection which is unable to withstand the system's operating requirements.

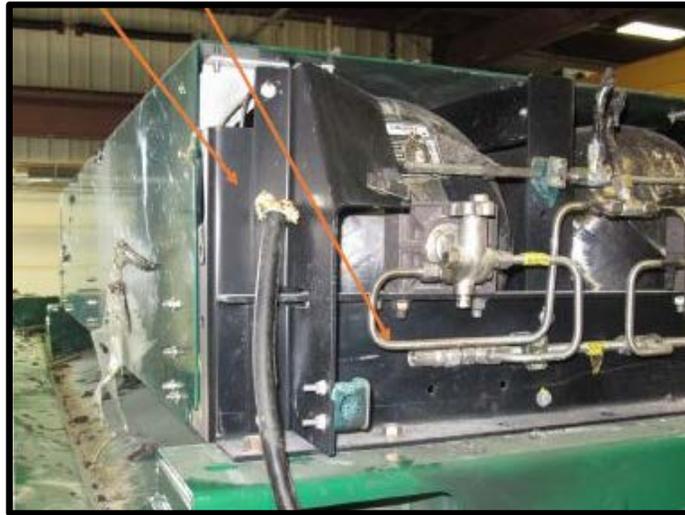
34. The image below of the subject refuse truck taken after the January 11, 2017, explosion shows the remnants of this failure mode: the hose end identified by the left-most orange arrow blew off the fitting identified by the right most arrow:

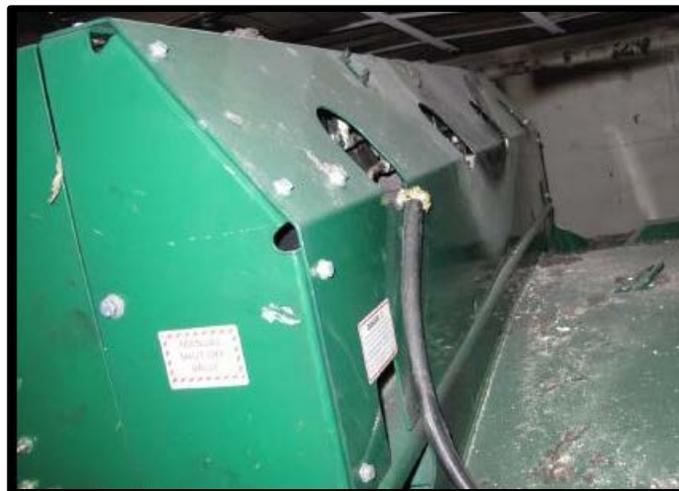
35. The above view shows the truck with the cowling cover removed; the image below shows the hose separation before removal of the cowling cover:

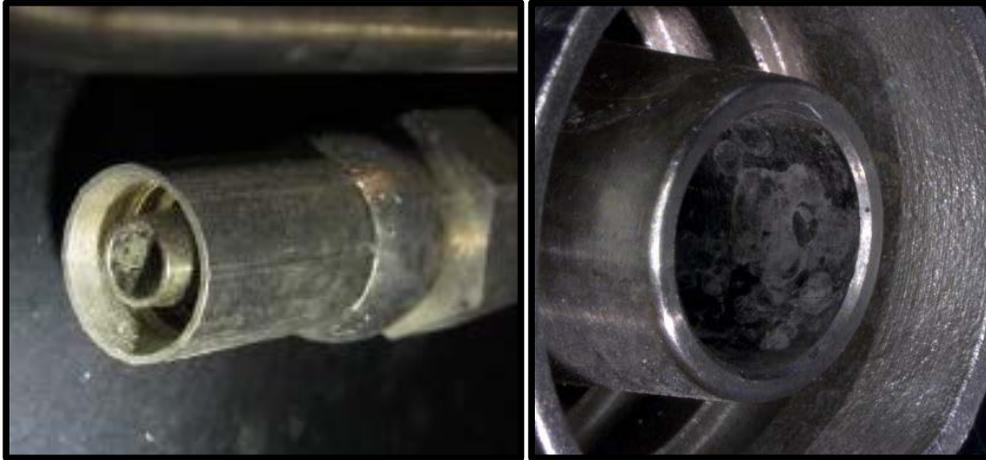
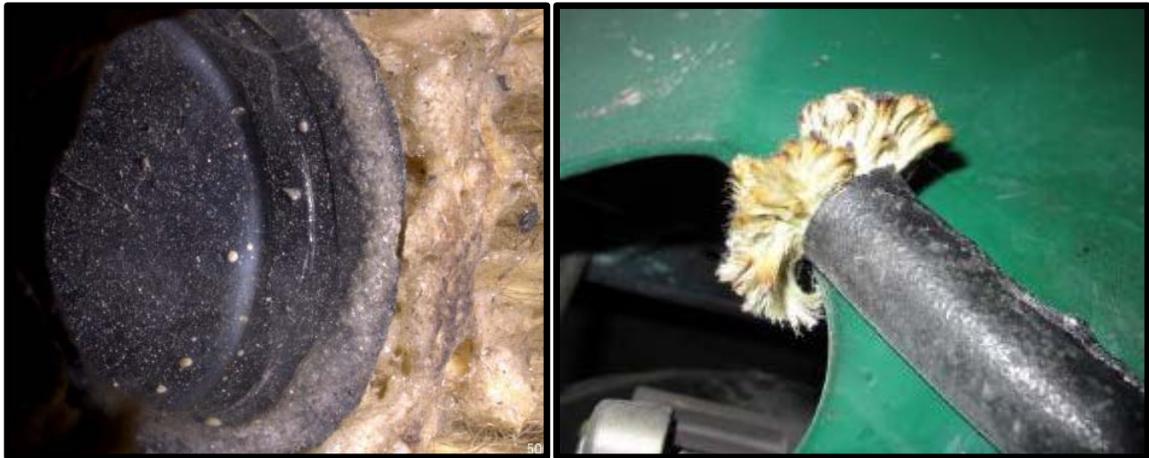
36. Close-ups of the hose and fitting ends can be seen in the photographs below. Technical analysis confirmed the lack of engagement of the hose assembly due to Defendant Swagelok's failure to fully engage and seat the hose within the fitting prior to compression:

37. As shown in the above photographs taken after the explosion, the “failed” end of the hose reveals a complete dislodgement of the hose from the crimp connection of the metallic fitting end (interior view of the hose end, at left; note the only two circumferential ring indentations from the proximal end of the barb tip).

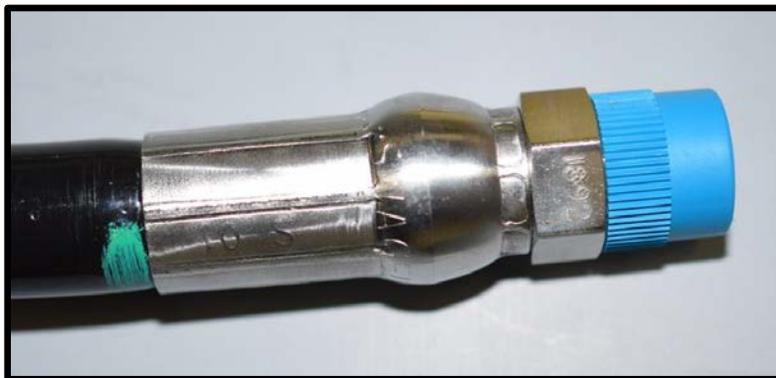
40. In fact, if Swagelok actually did what it claimed to do, the failure to properly seat the hose would have been easily detected and would have prevented the January 11, 2017, explosion and the catastrophic injuries suffered by Claudia Arevalo Linares. Among other reasons, a properly assembled hose has a simple marking – which should be made before the hose is inserted on and into the fitting – showing the proper insertion depth.

41. In the photograph above of an exemplar Swagelok hose assembly, the green marking on the fabrication just outside the metal fitting was made to ensure that the hose was fully inserted into the coupling prior to compression of the metal coupling onto the hose. The Swagelok hose assembly which failed on January 11, 2017, lacked such a marking to ensure proper insertion depth. As a result, the subject hose was not fully inserted into the metal fitting and there was not enough clamping length to securely connect the hose to the fitting.
